The Restoration of ex-Mexicana de Havilland Comet 4C 6424 by the Museum of Flight, Seattle, WA

A compilation by the de Havilland Aeronautical Technical School Association

Last updated May 2014

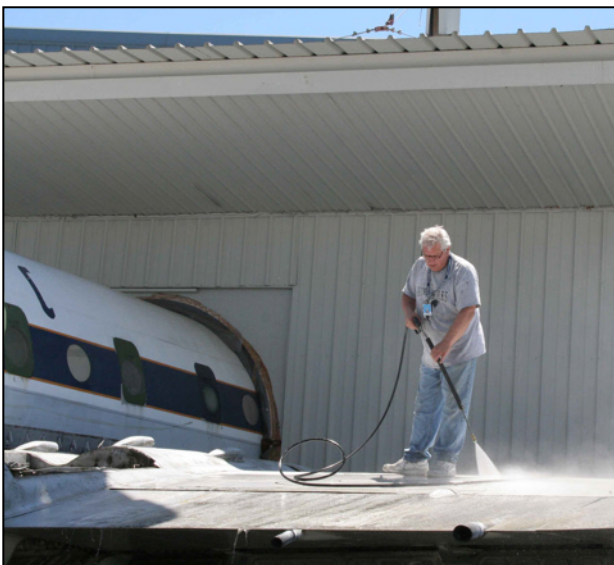
Project Manager Jim Goodall removing accumulated moss from the wings.

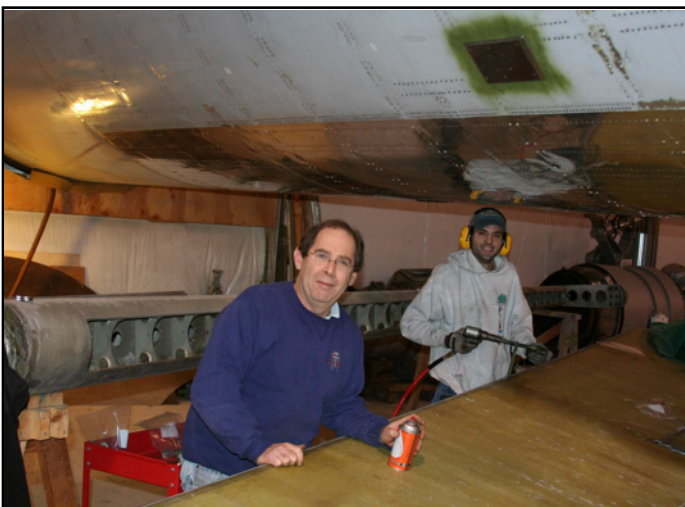
Steve Belanke and Mike King repairing elevator corrosion

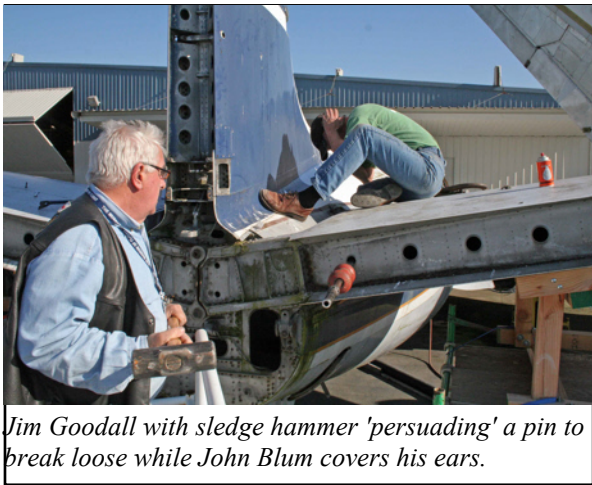
Jim Goodall with sledge hammer 'persuading' a pin to break loose while John Blum covers his ears.

The great event this year took place 14th August with removal of the second (starboard) horizontal stabilizer. (The port stabilizer had been removed two days earlier.) For those not familiar with Comet construction, the magnitude of this event requires some explanation. The fore and aft main spars of these surfaces are joined by four large (1.5 inch diameter by 5 inch long) pins. Our restoration crew is prepared to swear (legally and pejoratively) that these pins were designed to never be removed. We spent about six weeks trying to get them out.

However, our good friend at RAF Kinloss, Rab Logan, reassured us that they are routinely removed during major Nimrod inspections. He gave us very detailed instructions. Their technique employs a combination of heat, very high torque, careful adjustment of the stabilizer weight load on the pins, hydraulic ram pressure, and a ten-pound slide hammer. We used Rab's advice and were pleased to find that these techniques did break loose three

of the pins from their forty-nine year sojourn (they had not been removed since their 1959 Hatfield installation). However, the fourth and most-difficult-to-reach pin (in the upper forward location) was not as cooperative. At Rab's suggestion, we bored out this hardened steel pin to 0.75 inch diameter (a many hour task), heated it, then poured liquid LN2 into the cavity – hoping that thermal shrinkage would help. It did not. A few days later, we acquired a six point impact socket and enlisted Dave McKee, the Restoration Facility's strongest volunteer, to apply maximum force on the pin using a breaker bar with pipe extension. After carefully fitting himself into the small compartment behind the forward spar, we heard a groan, a grunt, and a "bang" like the firing of a small cannon. THE PIN HAD BROKEN LOOSE. Moral to this story: BRUTE FORCE artfully applied DOES WORK.

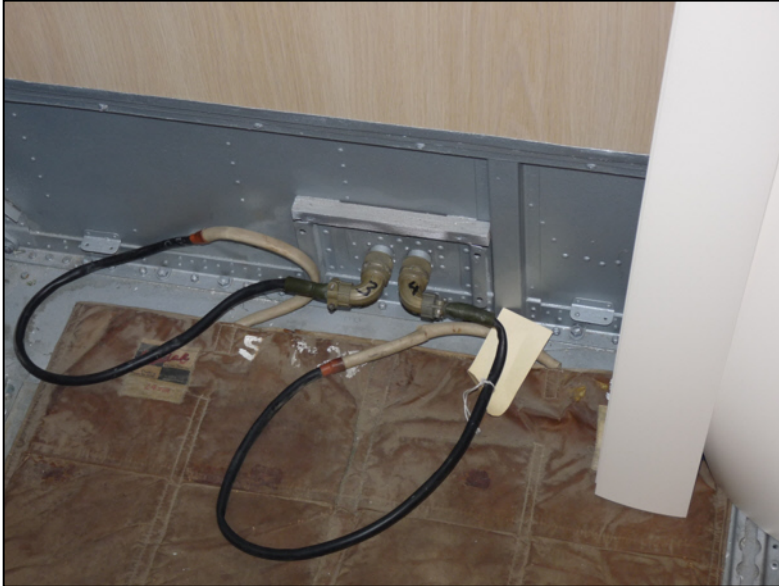
Center section under carpet floor heating "electric blanket" (important passenger comfort item, as the floor here is a pressure bulkhead and the fuel tanks below would track the -75 degree F OAT at altitude).

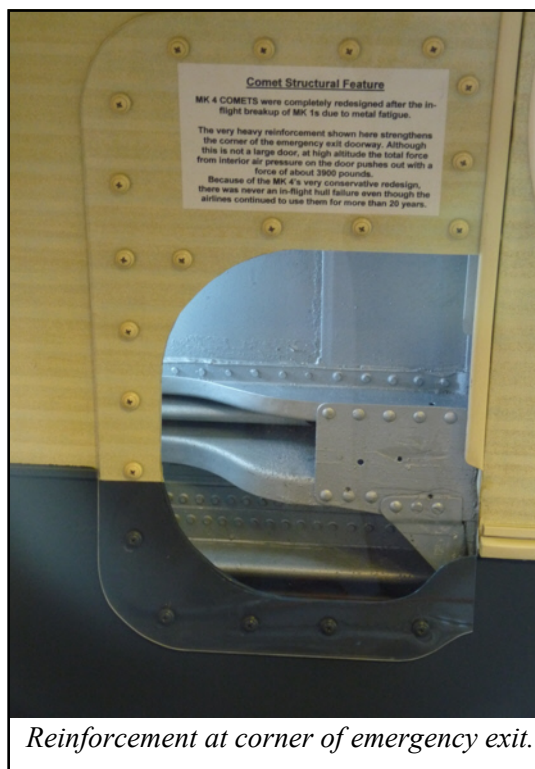
Reinforcement at corner of emergency exit.

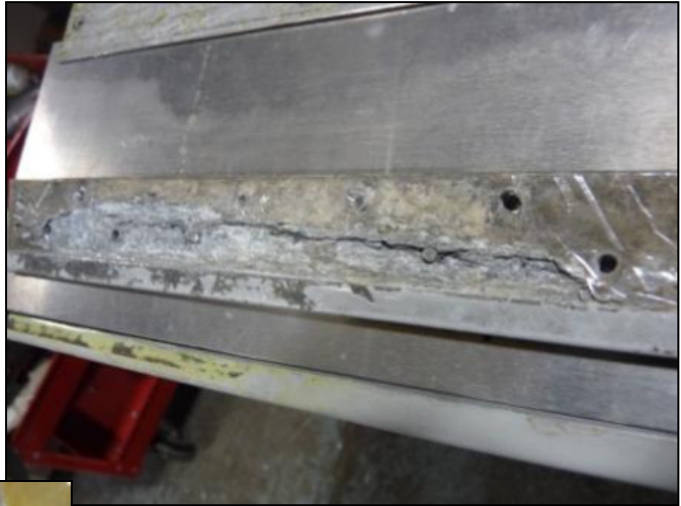
Figure 11

Port inboard flap trailing edge – before restoration.

Further work in the hangar concentrated on restoration of two port wing flaps, which were found to be in very poor condition with cracks and corrosion. The inboard flap's trailing edge has a milled aluminum wedge strip which had the advanced corrosion seen in Figure 10, and we did not have the resources to duplicate the part. Then, our Scottish volunteer again came to the rescue! He talked a friend into removing the same strip from a decommissioned Kinloss Nimrod flap and then mailed the part to us. Elsewhere, the flap panel's many cracks and patches required a surprisingly large time commitment. To finish flap restoration, we plan to build temporary flap bead blasting chambers in 2012 to clean up leading edges. After that, the panels will be corrosion protected and stored in the hangar's protected environment.

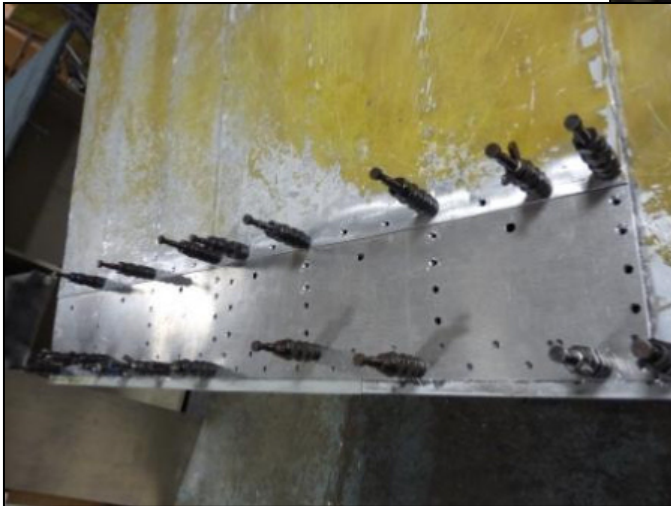
Figure 12

Port inner flap trailing edge – during restoration .

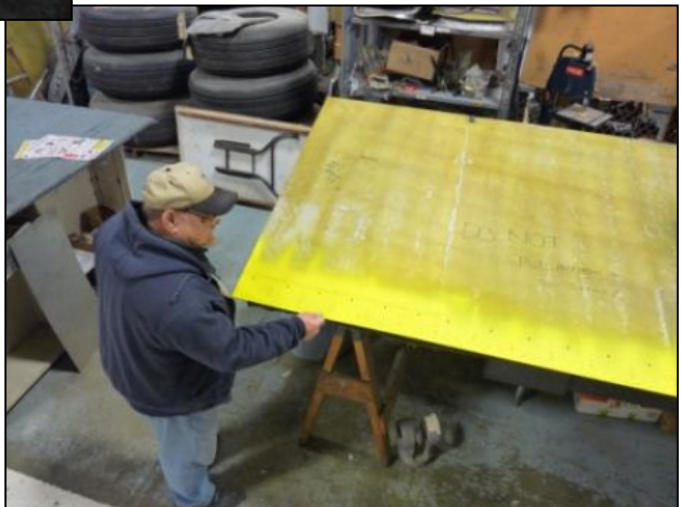
Figure 13
Finished flap trailing edge.

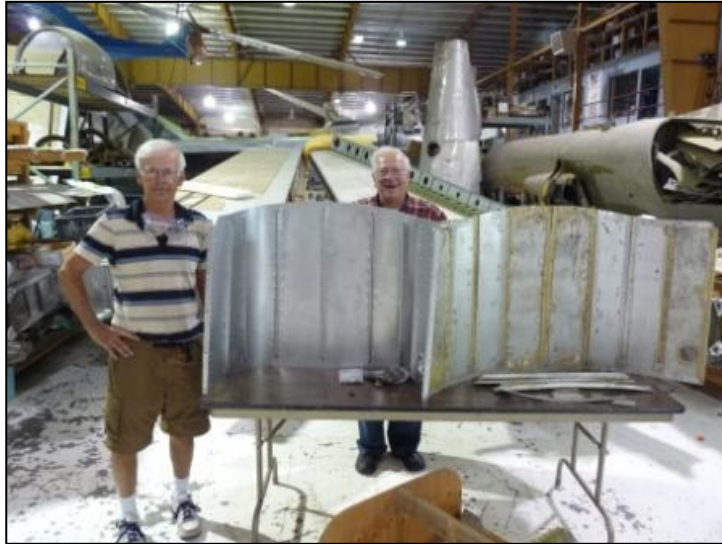
Figure 8 Aileron Control Bay – aft baggage compartment barrier --- before (right) and after (left).

The major Comet interior event of the year was completion of the Aileron Control Bay exhibit. This compartment, with its clear acrylic floor panels clearly reveals the Comet designer's great care and many redundant features of the Comet's fly-by-hydraulics aileron control. (The aisle center acrylic panel is structurally supported by a carefully made look-alike beam fabricated to duplicate DH practice elsewhere.) Attention was given to reproducing all of the major cables, hydraulic lines and servo piston linkages in this compartment. A track light system using custom designed LED sources to avoid incandescent lamp burnout highlights the compartment's features, including the cabin pressure regulator assembly. Man-months of work beginning more than a decade ago are vindicated by the visually striking final result.

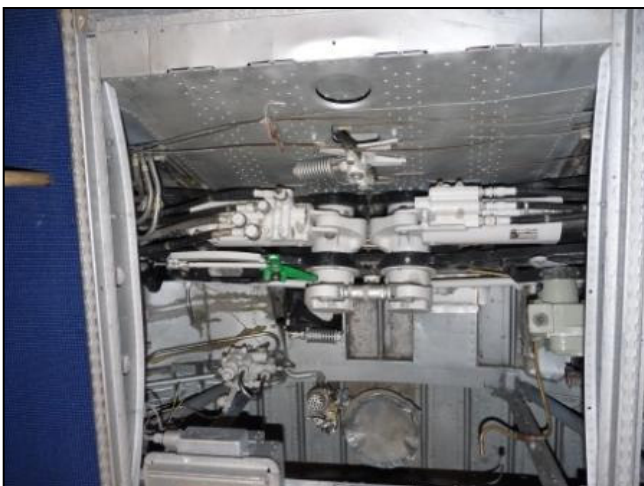
Figure 9
Aileron Control Bay under restoration.

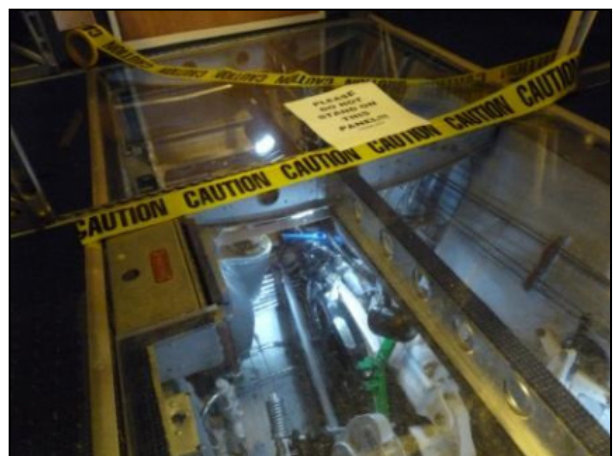
Figure 10
Aileron Control Bay viewed through its clear acrylic floor panel.

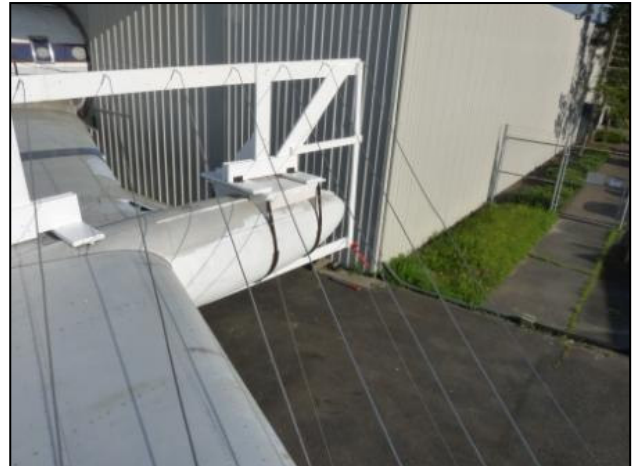
Figure 3 Wing Support Cover Cables

The plan is to surround both wings with heavy gauge plastic shrink-wrap and pump dry air (at 20% relative humidity) into the space around them. The wrap's support cables are now in place, and we are attempting to defray the cost of the shrink-wrap itself. When done, we will have protected C/N 6424 from corrosion until the planned future controlled environment display hangar is funded and built.

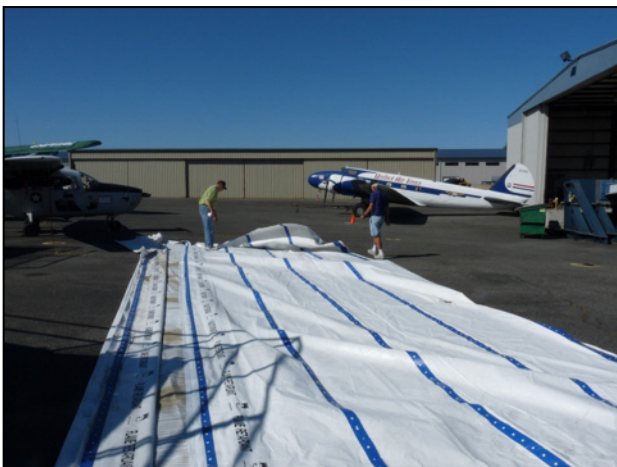
Figure 4 Assembling Wing Cover Fabric

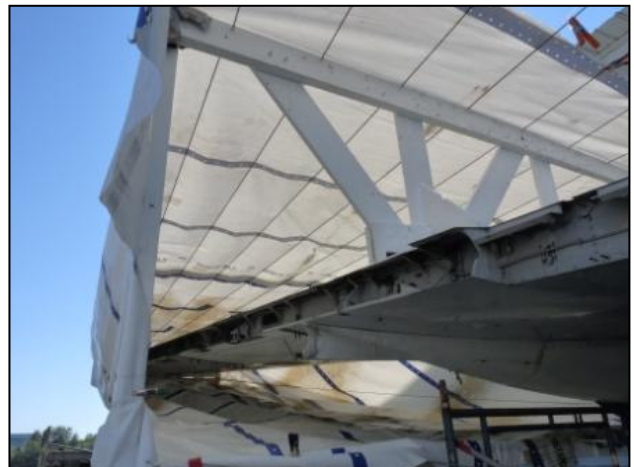
Figure 5 First Fabric Over Port Wing Tip

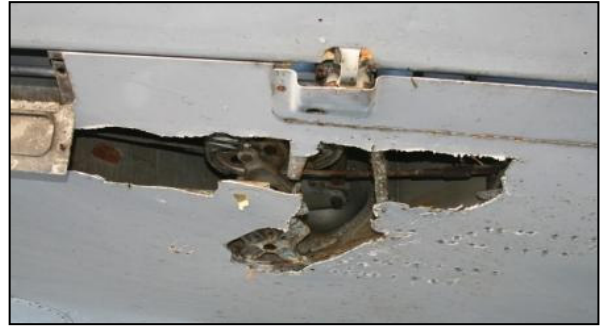
Figure 1 Corrosion Damage to wing bottom skin

Construction of a protective wing cover system was begun in 2011 to keep the wings in a controlled dry air environment using the same Munters dehumidifier that presently protects the Comet aft fuselage and the interior of the first Boeing 727. The whole Comet restoration crew will celebrate when the wing cover is complete because then the last Comet in the Western Hemisphere will be stabilized against further corrosion. Its future permanent preservation will wait until the Museum's planned large aircraft exhibit building has been funded and constructed.

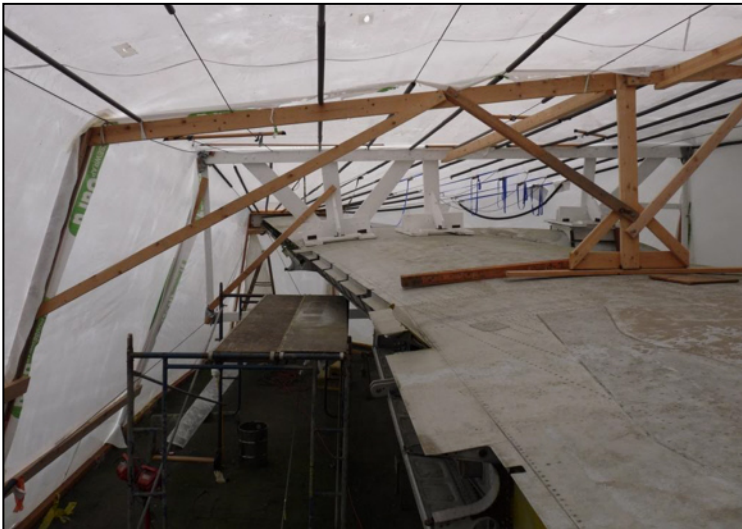
The new shrink wrap was in place for the winter of 2012/13, giving the wings their first dry winter since 1979.

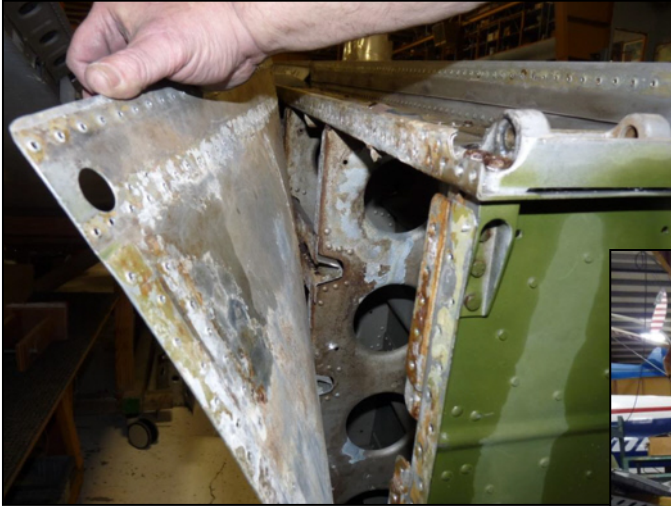
Horizontal stabiliser before restoration.

Repair work has continued on ailerons, flaps and the vertical and horizontal stabilisers. After an extended debate about the best way to manage the awkward and heavy restored horizontal stabilizer discussing the possible, but limited, number of ways to move and store the panel, a call to Scottish volunteer Rab Logan, gave the answer: A threaded nut buried under the panel's top skin near its c.g. was strong enough to provide a needed lift point. The stock of DH bolts from the ex-Mexicana/ex-Redmond Air inventory produced just the right thread for that nut. Rab had warned about possible corrosion at the nut site, but this panel fortunately had no corrosion. The lift point nut and bolt with two elevator hinge connection points was used with the battery driven hangar fork lift to move the panel from its vertical work site into its original storage position on the wheeled dolly.

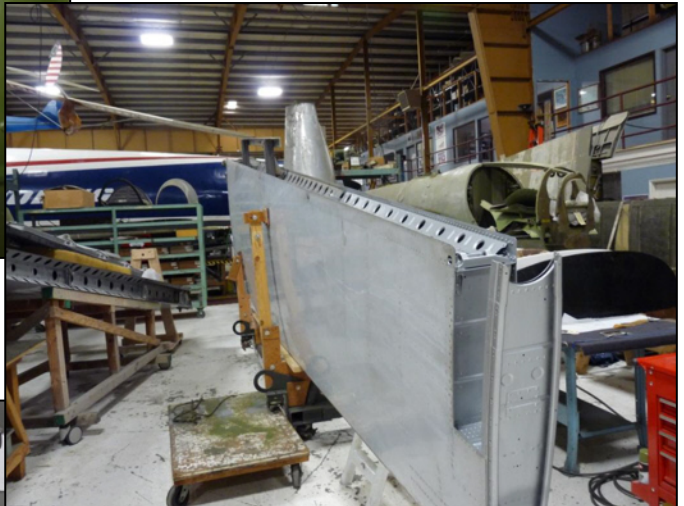
Horizontal stabiliser after restoration.

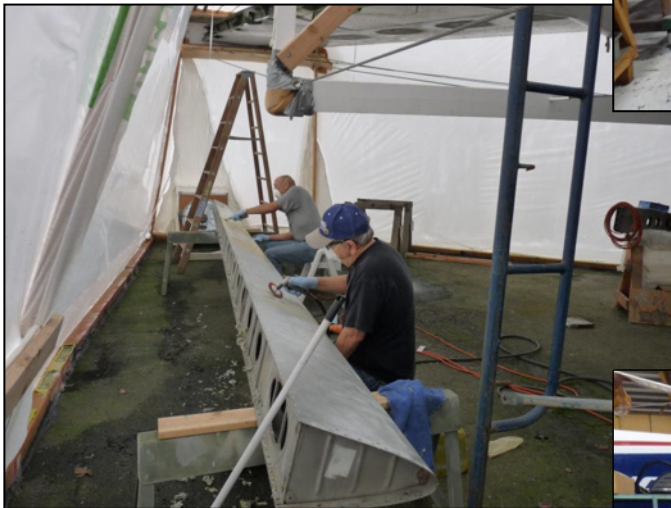
Part of vertical stabiliser under restoration.

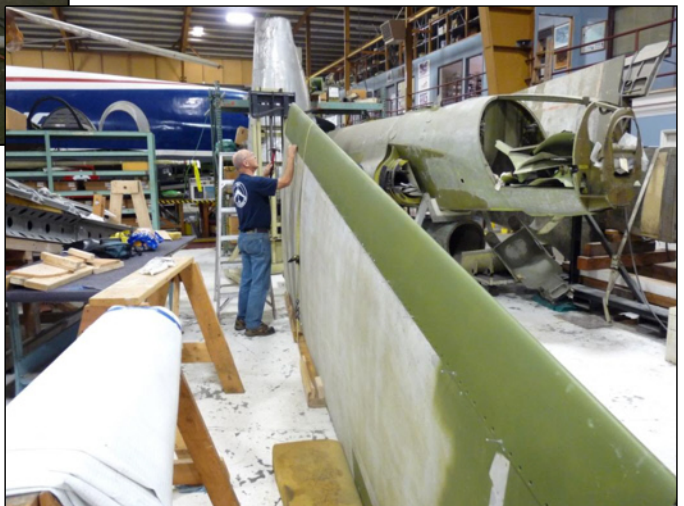
Vertical stabiliser after restoration.

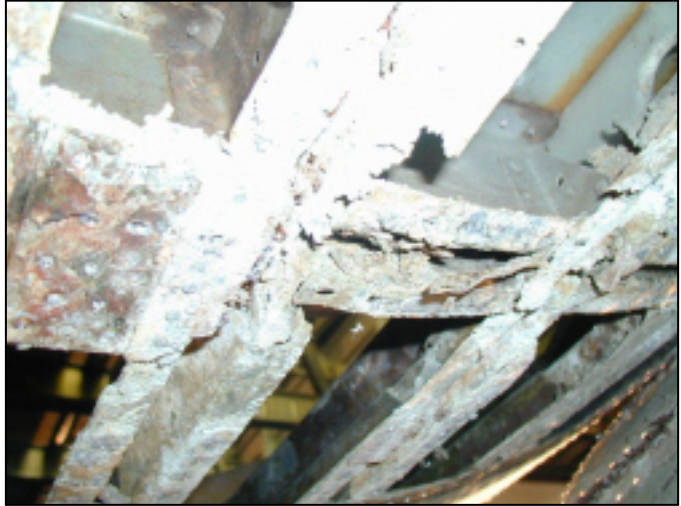
Attention has been given to various areas of corrosion and repairs made as practical and necessary. This picture shows what was found when the fuselage belly skin was removed.

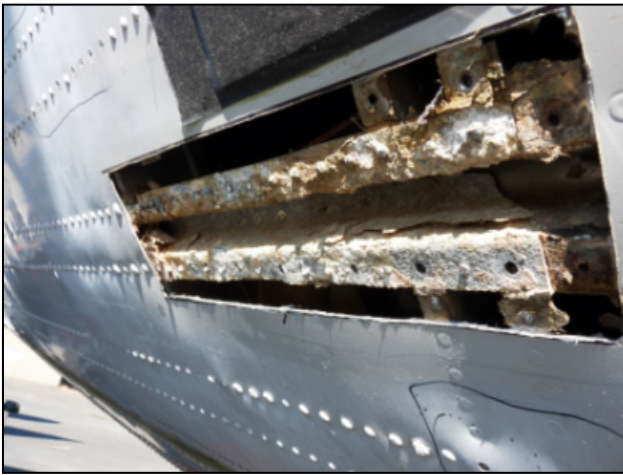
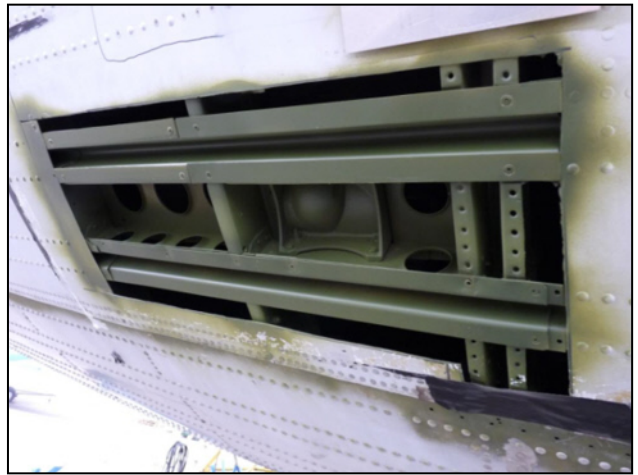
The pictures below are before-and-after shots of corrosion found when the skin behind the starboard aft galley was removed.

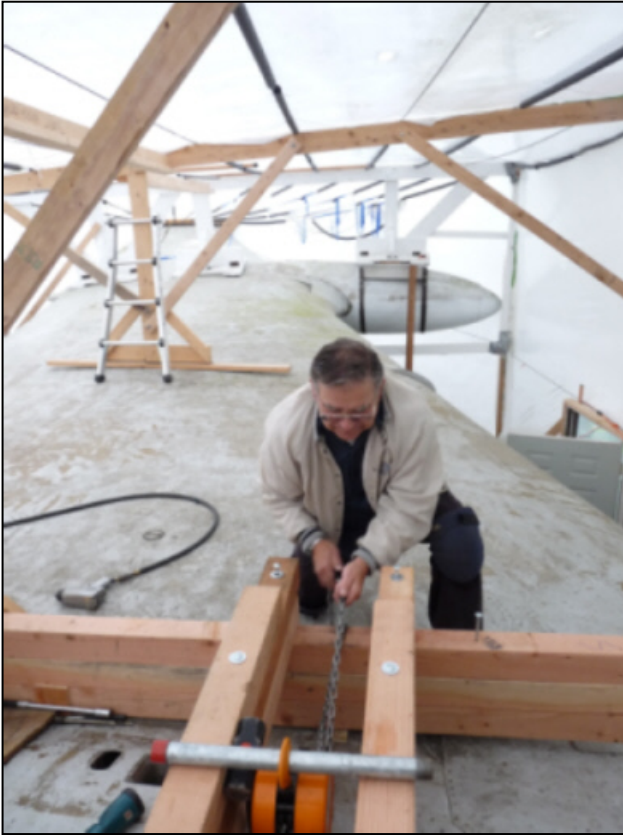
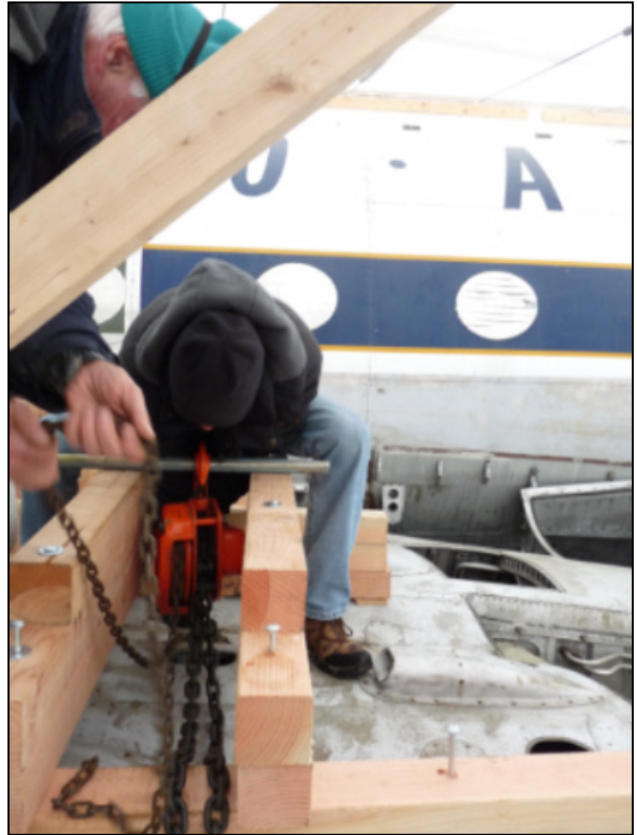
Above and left : lowering an engine.

The major achievement of the last few months of 2013 was the removal of all four engines. Dollies and a hoist had first to be made. A prop to support the tail also had to be made, because engine removal made the c.g. move aft. The first two engines were removed in late December 2013 and the remaining two in January 2014.

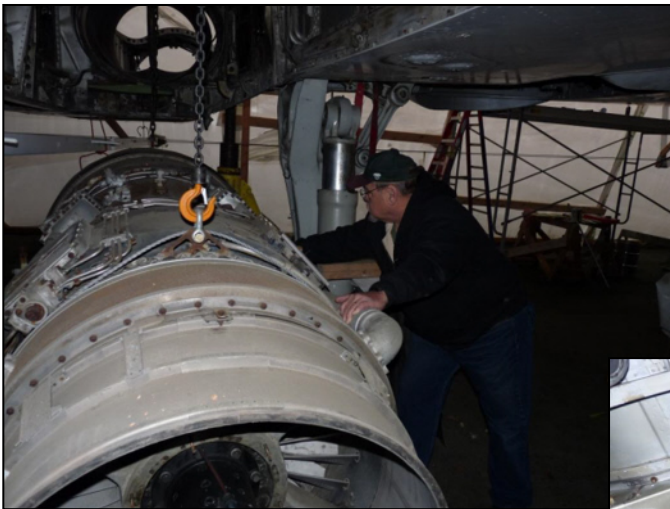
A surprisingly clean engine bay.

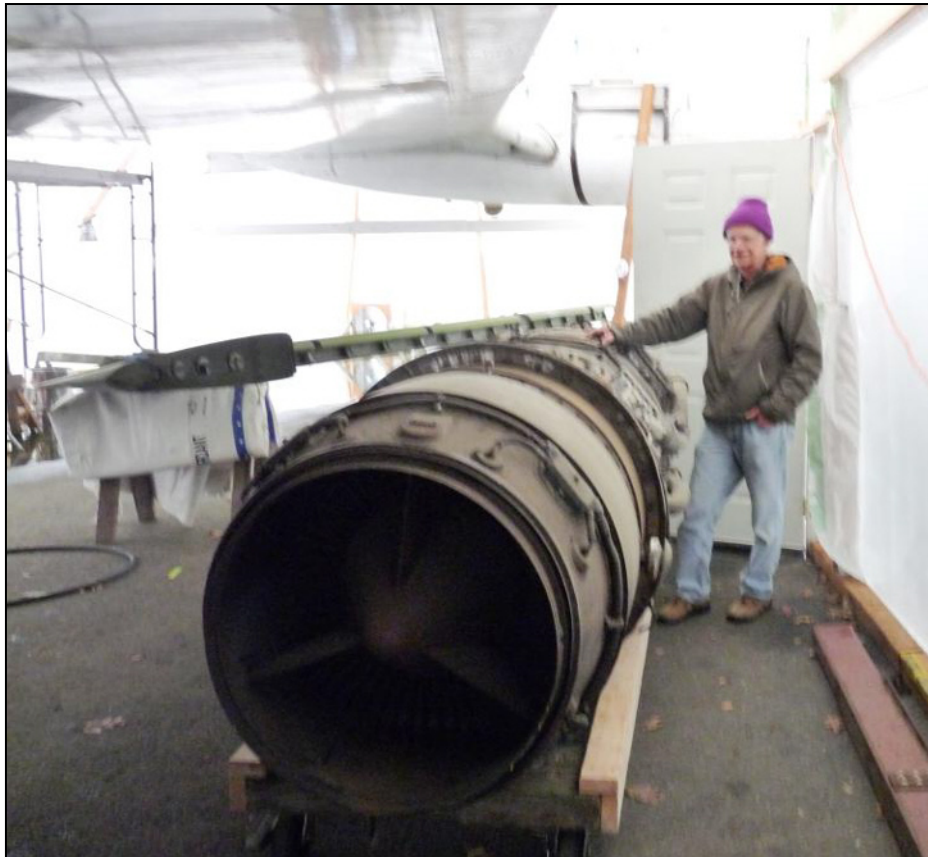
Engine on dolly

All four engines have very extensive corrosion damage to the magnesium inlet sections, with large white 'crumbles' lining the lower inlets and corroded see-through windows in parts of the casings.
